Manhole Inspection Summary

Manhole # S13OO1010MH

Insp Date: **11/29/06 8:47 AM**

Location Address: **2901 WOODLAND AVE**

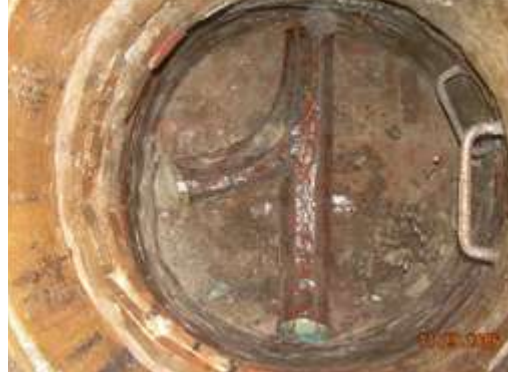
Top View

Barrel infiltration. Evidence of surcharge - Bench debris.

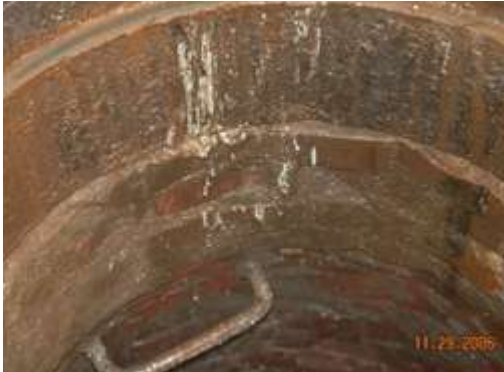
Defect

Frame leaks. Adjustment and Corbel infiltration.

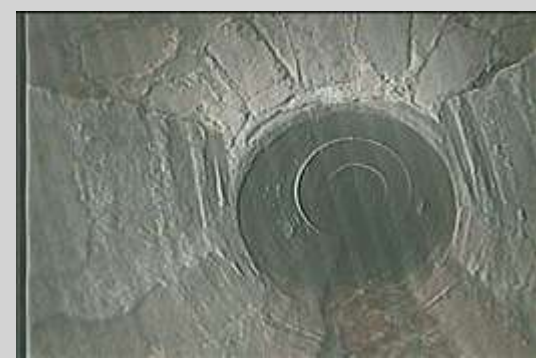
8 in. Circular Gravity Sewer Pipe Out @ 12 O'Clock

Infiltration: **Evidence** Pipe Seal Cond: **Cracked**
